Manhole Inspection Summary

Manhole # S47CC_041MH

Insp Date: **7/22/08 10:30 AM**

Location Address: **916 N. Port St.**

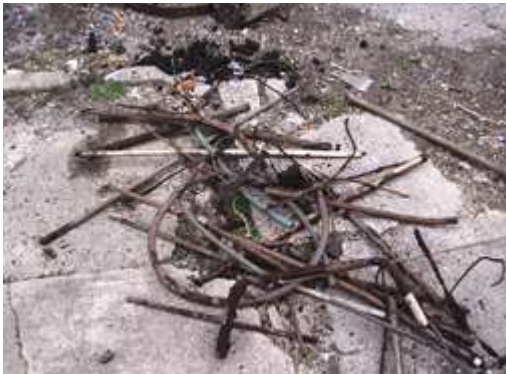
Defect 2

Condition: ☐ Sound ☐ Cracked ☐ Root Intrusion ☐ Deteriorated ☐ Leaks ☒ **Debris**

debris

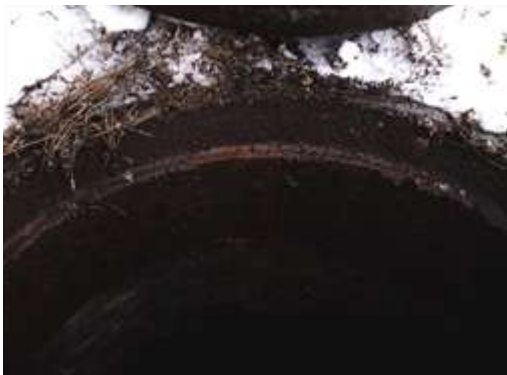
Defect 1

☒ **Leaks**

frame

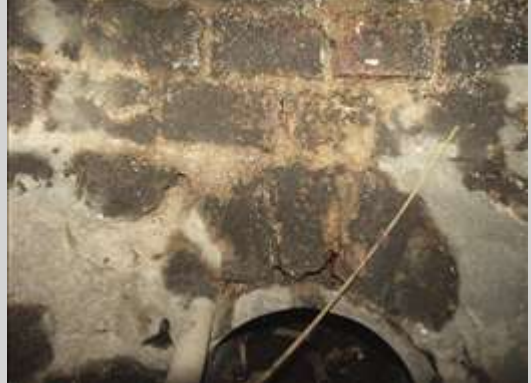
12 O'Clock Outflow

8 in. Circular Gravity Sewer
Pipe Out @ 12 O'Clock

Deposits: ☐ None ☐ Mud ☐ Sludge ☒ **Debris** ☐ Grease

Silt Depth: **3** (in.) Deposits Extent: **Heavy**

Infiltration: **Evidence** Pipe Seal Cond: **Cracked**
